Slinden Services Ltd

Daimler 6 Cylinder

A Daimler 6 Cylinder Block was received at our works for a full inspection/quotation.

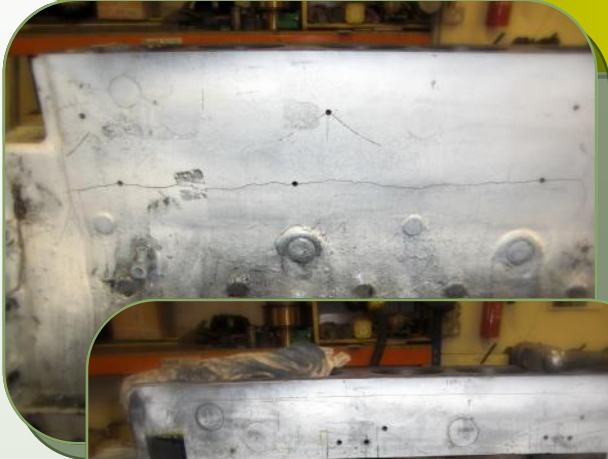
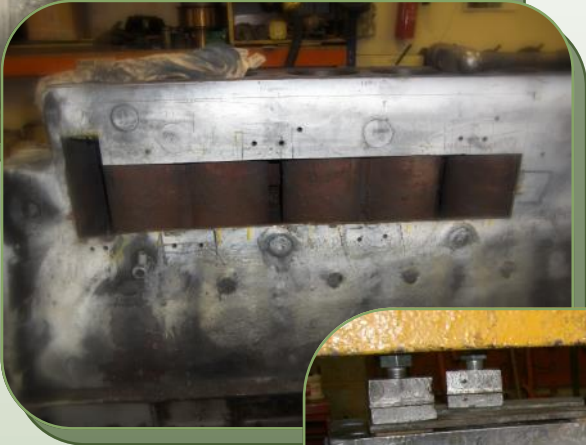
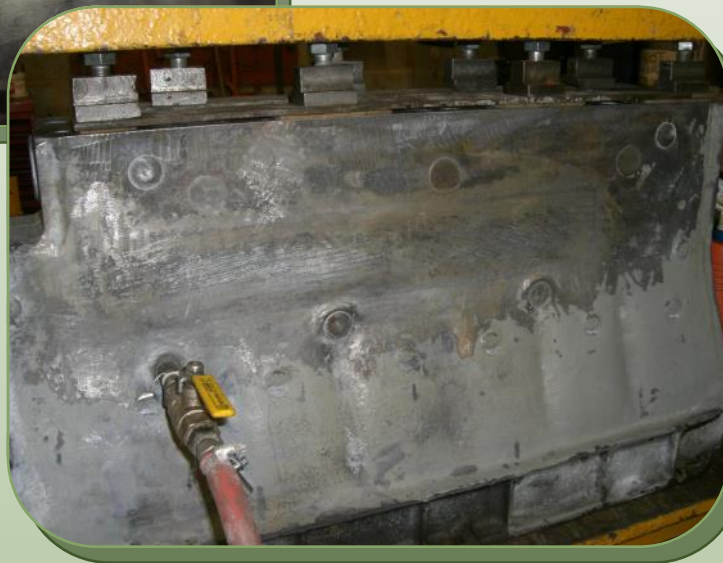
As you can see from the photographs this block was basically scrap (the frost damage ran the full length of the block!!) - but with our lock and pin procedures we brought the block back to life.

This was an extensive process and due to the cracks inside the water jacket the best option

was to remove the side wall, make a new cast iron panel then lock and pin into place, pressure tested to 50psi air pressure (see picture left)

This repair has now given our client a reconditioned block with many years of service, to enable this
