Slinden Services Ltd

Cast Iron Welding & Metal Stitching Repairs

Diahatsu DL280 Head

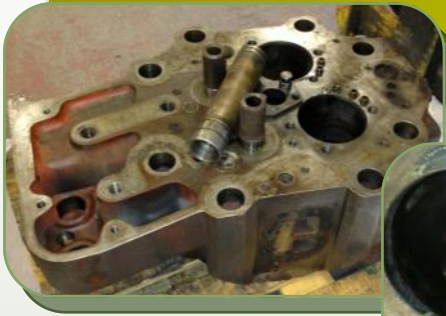
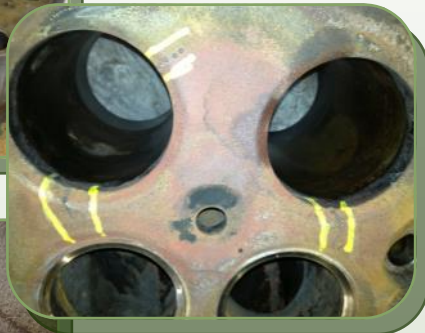
When a world-wide marine company sent us a Diahatsu DL280 cylinder head for repair, close inspection revealed it had cracks from the valve cages to the flame face, and also the water passageway holes were badly corroded.

We undertook repairs by way of our Lloyds approved fusion welding procedures before NDT inspection to ensure repairs were sound, then machined back to correct tolerances and fitted spare parts. This was followed with a thorough cleaning and painting, before the head was witnessed under pressure by Lloyds for certification purposes prior to dispatch.
