Slinden Services Ltd

Bronze Impellor Repairs

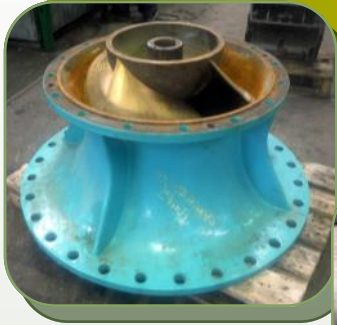
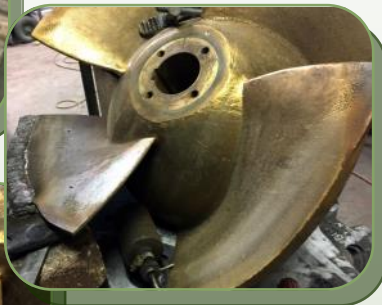
We were contacted by a customer who had *“a pump in our works for which the top bearing has failed allowing the impellor to rub against the casing. The blades of the impellor require rebuilding and profiling to suit the casing. We estimate the tips require building up by approximately 20mm”*.

The impellor was brought into our workshop for emergency repairs to all 4 blades – a pattern was made in preparation for the building up of all blades by the 20mm required as per our approved procedures for bronze welding. All were ground to shape following the manufactured pattern, then sandblasted and refitted into the casing before final inspection, and customer collection.
