Slinden Services Ltd

1908 Niclausse T Head Repairs

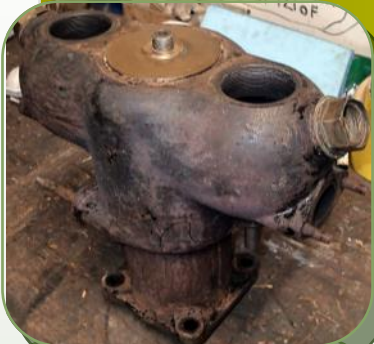
We received an enquiry regarding a vintage 1908 Niclausse engine...

"There's a large crack in the water jacket of one of the T heads. Please inspect, and advise as to how best to facilitate repairs".

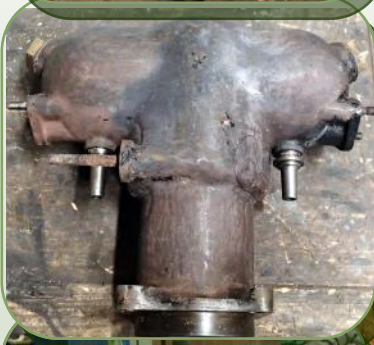
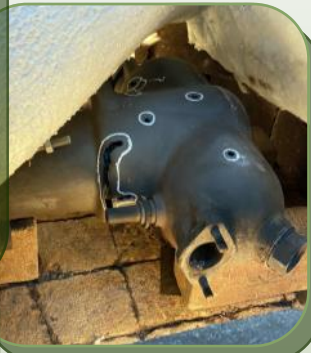
Upon testing, various cracks and leaks were found, and silt was blocking the bottom half of the water space (which we removed by way of cutting slots around the lower area and cleaning out thoroughly).

Repairs of all cracks and leaks were undertaken using our Lloyds approved fusion welding procedures for cast iron.
