# Slinden Services Ltd

Cast Iron Welding & Metal Stitching Repairs

## 1916 Allan Hot Bulb Engine

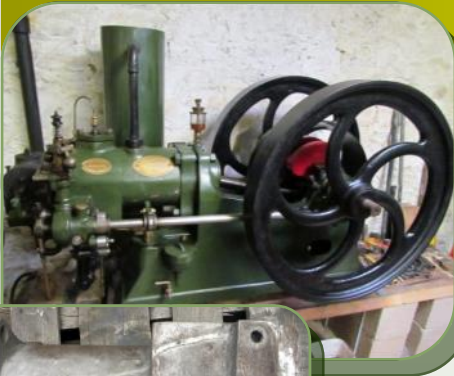
We received an enquiry for the repair of a 1916 Allan hot bulb horizontal oil engine cylinder which was welded by its previous owner. Sadly, the welds (varying from 6mm to 10mm) were cracking at the edges due to the hardening of the cast iron during welding.

We undertook repairs to the old welded areas by way of grinding out all the old welds before using our Lloyd's approved fusion welding procedures - also putting a layer of weld all the way around the liner contact area on the cylinder skirt contact face.

After grinding and crack testing, we machined the liner landing skirt area back to the nominal o/d and re-drilled and tapped the threaded hole, then bead blasted and primed, ready for collection.
