# Slinden Services Ltd

## Bronze Impellor Repairs

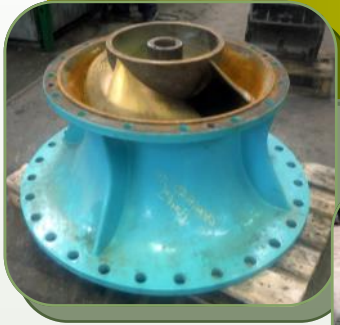
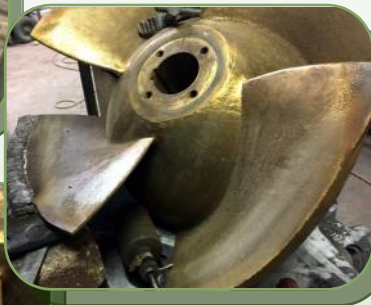
We were contacted by a customer who had “a pump in our works for which the top bearing has failed allowing the impellor to rub against the casing. The blades of the impellor require rebuilding and profiling to suit the casing. We estimate the tips require building up by approximately 20mm”.
