# Slinden Services Ltd

Cast Iron Welding & Metal Stitching Repairs

## Calendar 4 Gearbox Casing

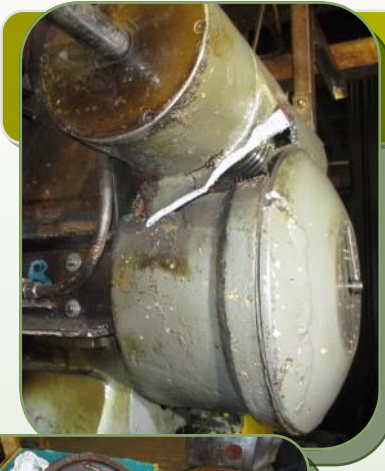
When a renowned tyre manufacturing company contacted us requesting emergency repairs of a broken Calendar 4 gearbox casing and cracked cover plate, along with the two main bearing housings which had brought production to a halt, we were more than happy to help them out!

The gearbox casing and cover plate were stripped and crack tested before fusion welding to our Lloyds approved procedures for cast iron. They were then shot blasted, followed by grinding to existing shape. Next, full machining was carried out to all faces, re-drilling and tapping of holes, making a sleeve and fitting to ensure bearings would fit, and then returned to site.

The refurbishments to the bearing housings involved the removal of the old bronze inserts, fitting of new ones manufactured by ourselves, machining of all internal faces as needed to drawings supplied, drilling of an oil hole, before cleaning, dressing and returning to site.
