# Slinden Services Ltd

Cast Iron Welding & Metal Stitching Repairs

## Cast Iron Fireplace

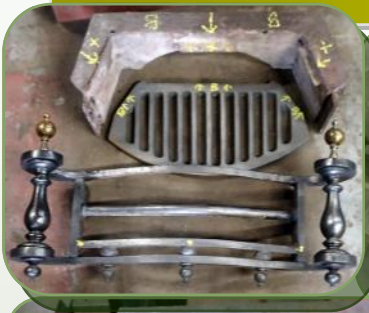
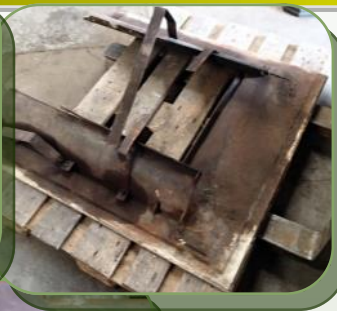
This fireplace was brought into our workshop by a building contractor carrying out restorations and refurbishments to a country estate property.

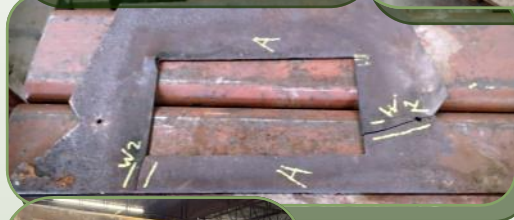
There were four areas to concentrate on repairs: the top flue plate, the hearth base, fire grate, and the side 'cheeks' all required fusion welding repairs by way of our Lloyds approved procedures for cast iron, and the front grill needed

re-welding of previously repaired areas, before crack testing and bead blasting of all welded parts.

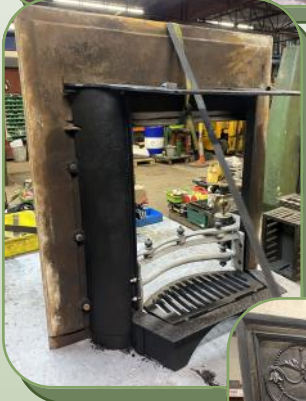
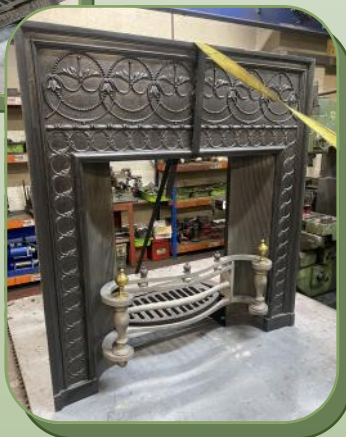
It was necessary to remove, drill and tap many old fixing points and allow for new fixing and bolting points, then build up the whole structure to check alignment and fitment, prior to collection and the final phase of black leading of the fireplace once back in situ.
