Slinden Services Ltd

LeFort 600 Shear Head

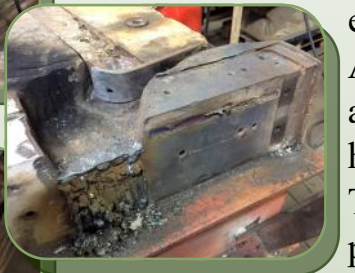
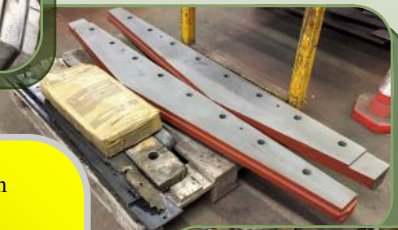
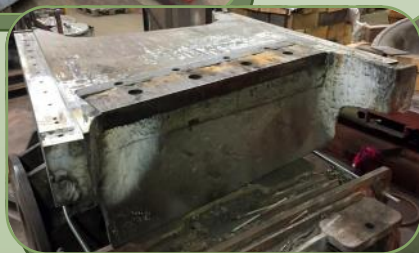
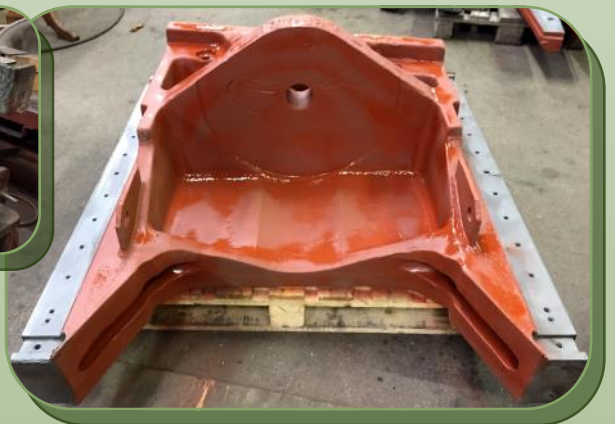
We were approached by an international scrap metal exporters when their LeFort 600 Shear Head needed urgent repairs, due to cracks and wear from daily usage.

When it came to our workshop the head was completely stripped down, removing the blades and wear plates, before undertaking repairs by way of our approved fusion welding procedures for cast steel, grinding up all welds to the correct profile to match existing shape, and fully crack tested.

After the welding and inspection process, we machined all faces before the drilling and tapping of missing bolt holes that hold the wear plates.

The Shear Head was then shot blasted followed by painting with a coat of red oxide primer before a final inspection, and collection by the customer.
