# Slinden Services Ltd

Cast Iron Welding & Metal Stitching Repairs

## NER Water Crane & Handle

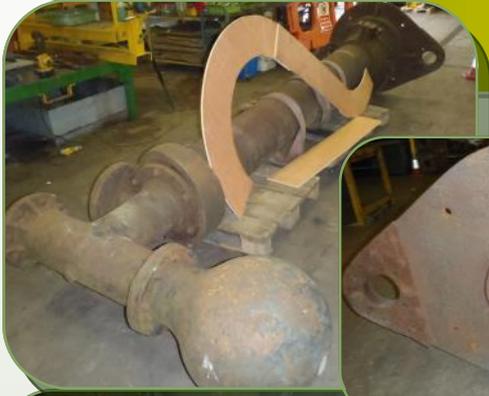
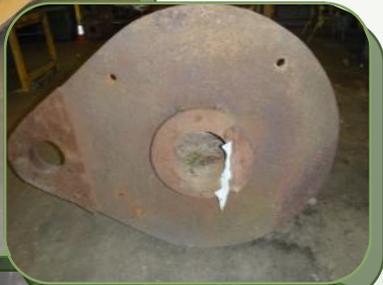
We are delighted to have been involved in the major restoration project on behalf of a Cumbrian Railway Company to fully restore to working order a vintage NER Water Crane complete with the water valve operators handle.

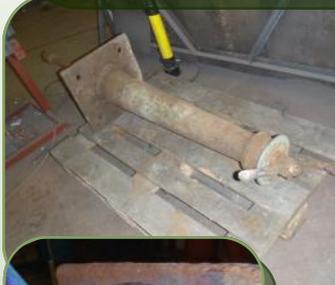
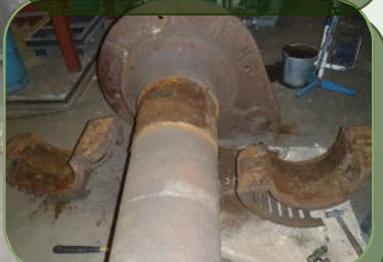
When the water crane arrived in our Derbyshire workshop, all the components were disassembled, shot blasted and crack tested, ready to begin the process of rebuilding.

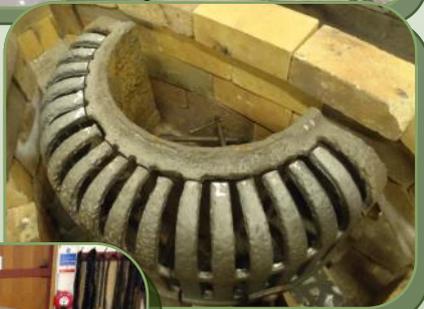
A rare feature of this water crane was the fire basket, which would prevent water from freezing in extreme cold temperatures, and also stop the cast iron from cracking...many of the original fire bars were missing, so a pattern was made from a good part of the casting and sent away to our trusted foundry to have the basket recast. Once cast, it was welded in and ground to shape before shot blasting and painting with red oxide primer and undercoat.

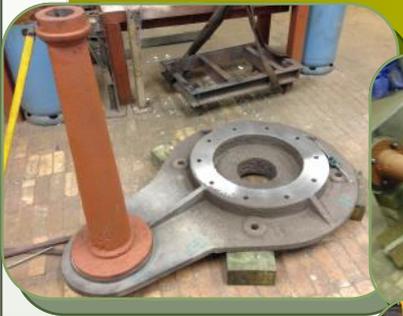
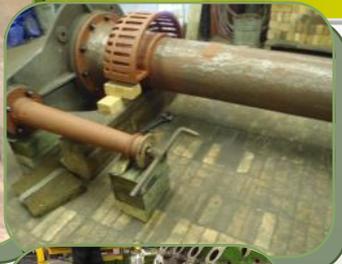
Modifications were then made to the base of the handle to fit the new base, and underground valves and pipes for the water flow to water crane were introduced below the main base plate, followed by pressure testing of all these parts.

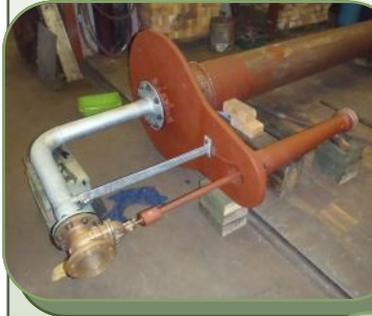
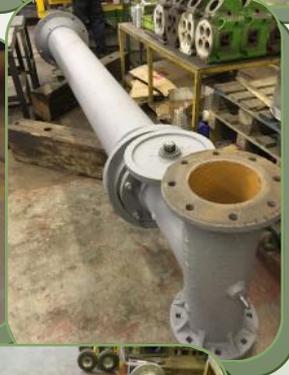
A main component which was missing was the elegant “swan neck” – the section which sits on top of the column and extends horizontally to carry water from the column to the loco tank. Again, a pattern was made and the swan neck cast, before machining and aging. We also redesigned and manufactured the finial and bracing which allows the counter-balance and swan neck to swing in any direction effortlessly.

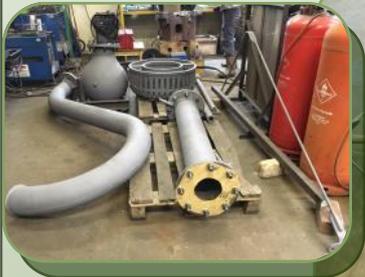
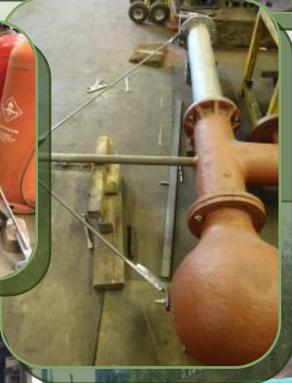
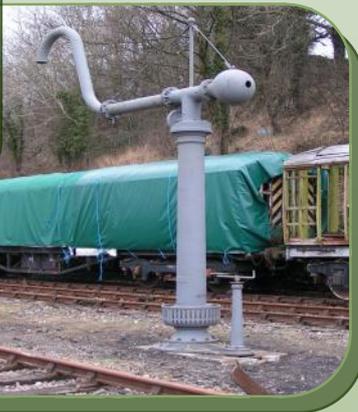
The water crane will now feed water from the newly restored water tower to the steam locos just off the end of the platform at Kirkby Stephen East Station for their many visitors to enjoy watching an authentic part of steam railway history in action!
