Slinden Services Ltd

Cast Iron Welding & Metal Stitching Repairs

Christie Clock Face Frame

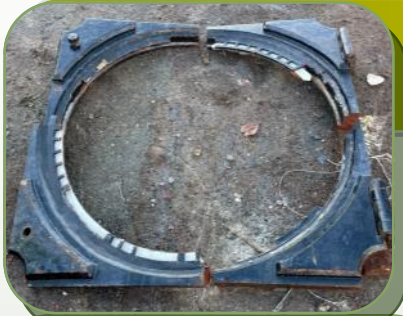
We were contacted by a customer needing help with repairs to a historical clock face frame which was broken into many pieces, but required the four main parts repaired via our Lloyds approved fusion welding procedures...

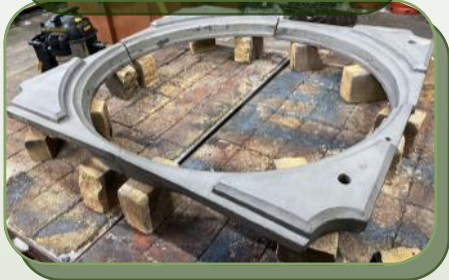
The four broken pieces were delivered to our workshop, stripped of any loose parts/hinges and shot blasted. The weld repairs were undertaken by way of our approved procedures for cast iron, ground to the correct profile

before crack testing, then shot blasted, and a black phosphate primer applied. The customer collected the clock face and would then be reinforcing the clock face with a stainless steel band for additional support.
