Slinden Services Ltd

Cast Iron Welding & Metal Stitching Repairs

Superheater Header

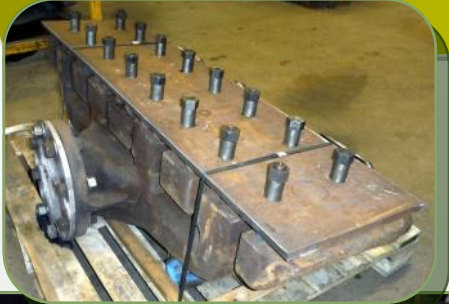
We were contacted by another vintage railway regarding a steam loco superheater header which was found to have a crack across a flange face, through a stud hole and into the body.

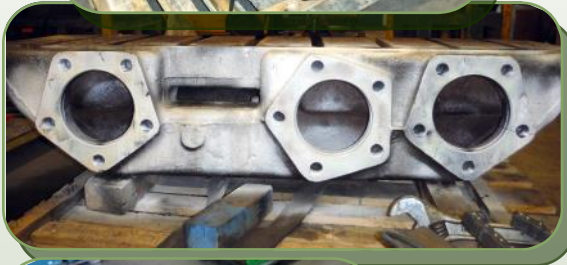
We arranged collection from the station, and once in our workshop, a thorough inspection found two more large cracks needing attention.

We undertook the welding repairs by way of our Lloyd's approved fusion welding procedures, grinding up all the
