Slinden Services Ltd

Cast Iron Welding & Metal Stitching Repairs

Diahatsu DL280 Head

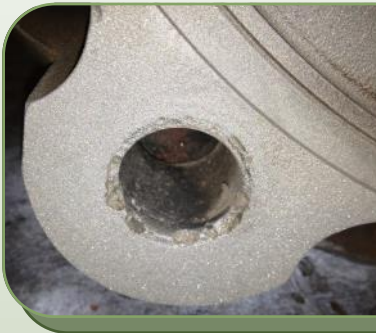
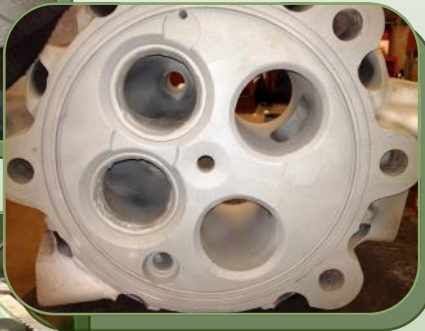
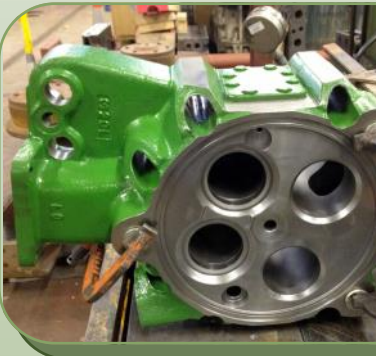
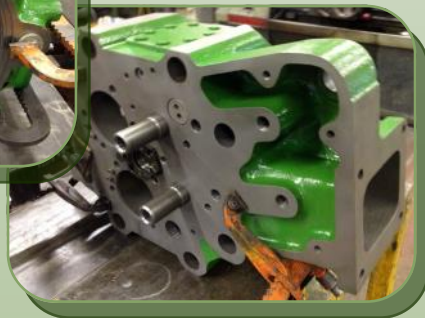
When a world-wide marine company sent us a Diahatsu DL280 cylinder head for repair, close inspection revealed it had cracks from the valve cages to the flame face, and also the water passageway holes were badly corroded.

We undertook repairs by way of our Lloyds approved fusion welding procedures before NDT inspection to ensure repairs were sound, then machined back to correct tolerances and fitted spare parts. This was followed with a thorough cleaning and painting, before the head was witnessed under pressure by Lloyds for certification purposes prior to dispatch.
