Slinden Services Ltd

Cast Iron Welding and Engineering

DE DEON 1903

A mono block for a De Deon 1903 veteran car was received at our works for inspection to see if we could repair?

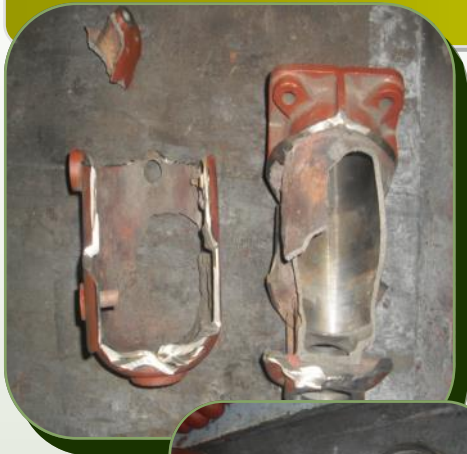
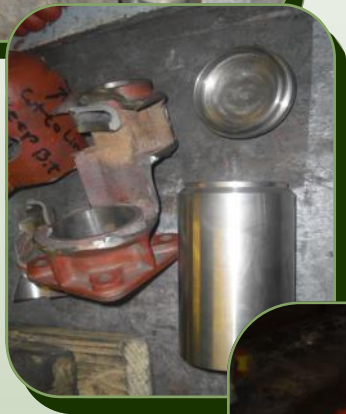
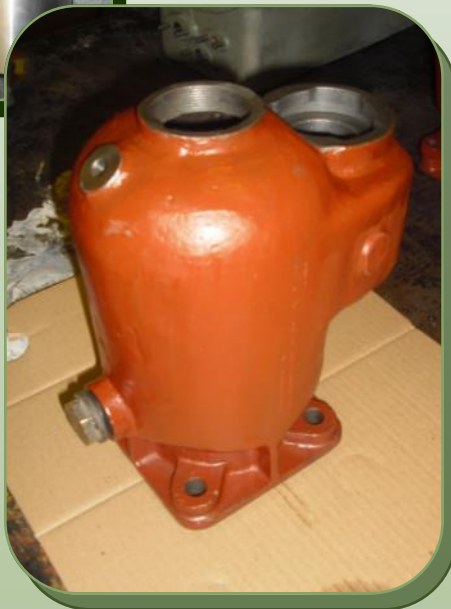
As you can see from the photographs this block was basically scrap (!!)- but due to the fact that this is an irreplaceable component we put our engineers to the test and began repairing this item using our approved Fusion Welding Procedure for cast iron material.

A new sleeve was made and combustion chamber cap which was subsequently machined to fit and welded into place. Following a full pressure test and crack detection the block was then fully machined to accept a standard piston.

This was an extensive process but has now given our client a reconditioned block with many years of service, to enable this veteran vehicle to be enjoyed by future generations to come!
