Slinden Services Ltd

Cast Iron Welding & Metal Stitching Repairs

Alfa Romeo SS Block

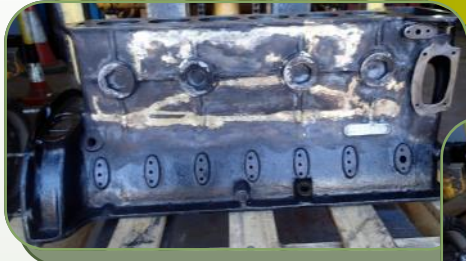
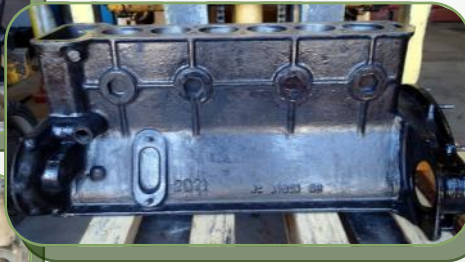
A Belgian customer brought an Alfa SS 6-cylinder block to our Derbyshire workshop for repair. It was in a bad way, with many cracks, holes, and old weld which needed removing and replacing.
