# Slinden Services Ltd

Cast Iron Welding & Metal Stitching Repairs

## 1932 Alvis Firefly Head

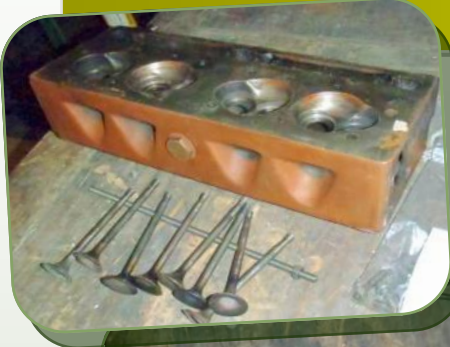
We were contacted by the owner of a 1932 Alvis Firefly cylinder head who explained that after many years excellent service the head had developed a water leak from below the valve inserts on the two centre exhaust ports from corrosion, age and heat. So, he sent his 4-cylinder head up to our Derbyshire workshop for us to inspect, "*fingers crossed that you can help*" .....
