Slinden Services Ltd

BALLOT 2LS

A valued customer of Slinden Services Ltd came to us with a Ballot Cylinder Block and Crankcase for our thoughts on repairs.

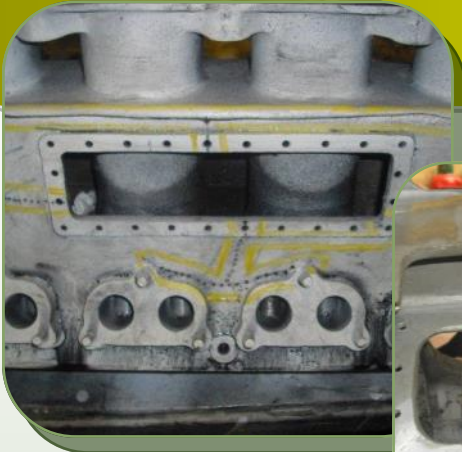
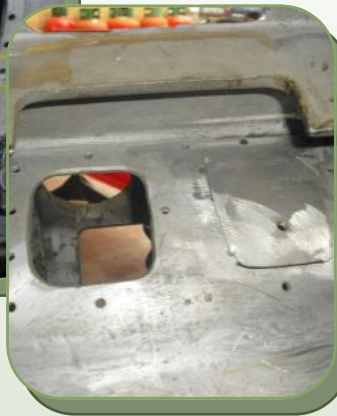
After inspection we found that the cast iron block was severely cracked and frost damaged on the outer water jacket area and in need of our expertise.

A thorough inspection of the aluminium crankcase found it too was cracked and also had previous failed extensive repairs which would firstly be removed.

Both items were repaired by way of welding, post weld machining and pressure testing to ensure sound repairs had been undertaken.

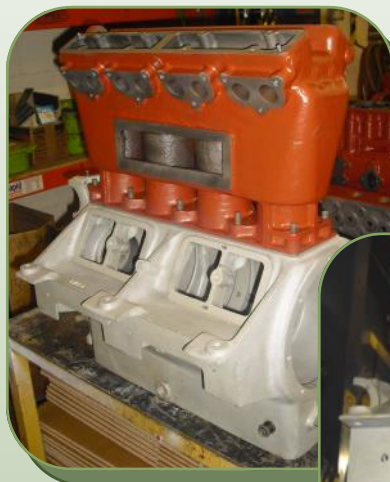
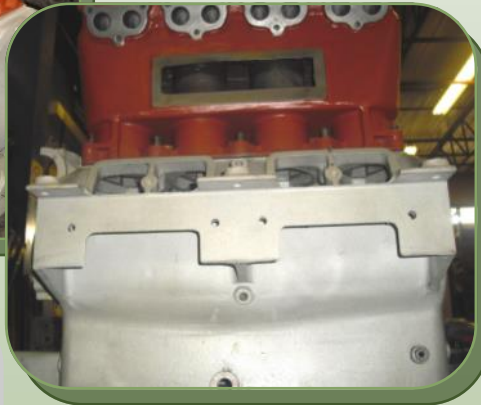
As you can see from the photographs before and after repairs - the components were back to original strength (if not stronger!) and ready for final machining and installation, thus restoring the original vintage engine parts for our client.
