Slinden Services Ltd

Cast Iron Welding & Metal Stitching Repairs

Cylinder End Cover

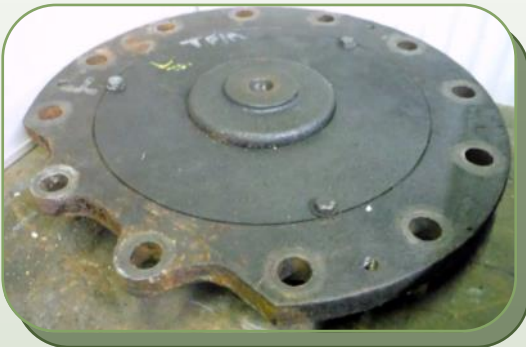
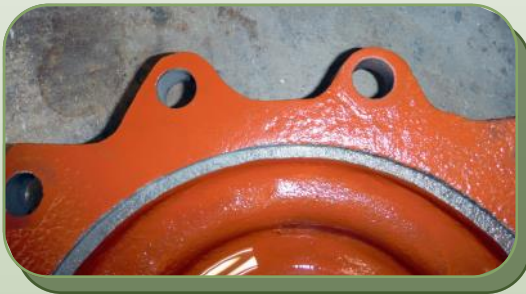
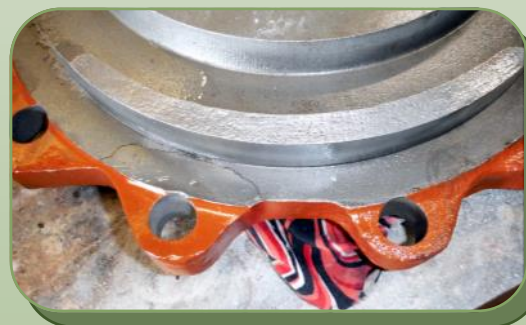
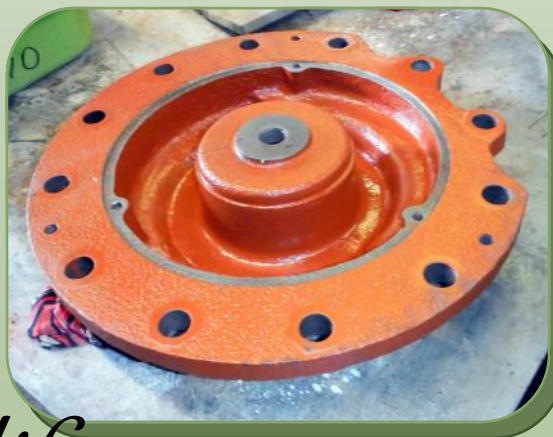
When our customer sent us a cylinder end cover off a steam loco, we set about inspection and crack testing which found the bolt hole lug was cracked, needing weld repair.

We undertook repairs by way of our Lloyds approved fusion welding procedures for cast iron, giving a repair as strong (if not stronger) than the original material. We then ground up all welds to the correct profile and fully crack tested, followed by shot blasting and a coat of red oxide primer, before dispatch back to the customer for machining and refit.
