Slinden Services Ltd

Cast Iron Welding & Metal Stitching Repairs

Fraser Nash Gough Cylinder Head

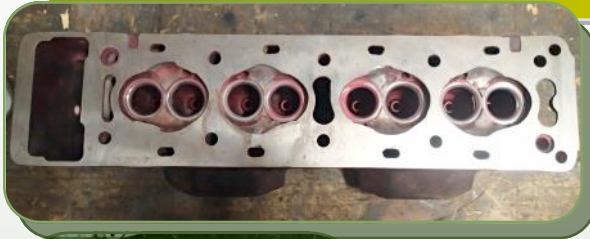
An interesting job came into our workshop from Ireland....a Fraser Nash Gough 4-cylinder head which needed some t.l.c as it is 1 of only 29 ever made, so irreplaceable! The customer explained the head had many cracks and leaks, and that *"it has been skimmed many times, so try to avoid taking any more off!"*

We began by prepping all the cracks ready for welding by way of our Lloyd's approved procedure for cast iron, along with the building up where necessary. All welds were then ground to the required specifications, before pressure testing and crack testing to ensure sound repairs had been undertaken. Next, full machining including all head faces, before a final blasting, fitting of spares, and finally, a coat of red oxide primer.
