# Slinden Services Ltd

## Hudswell Clarke Horn Guide Repair

Repairs were required for a Hudswell Clarke steam loco undergoing overhaul...

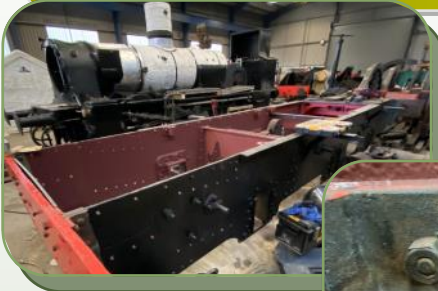
*"The part in question is a horn guide for a left leading axle box and is cracked diagonally across the top corner. Ideally, we don't want to remove the part from the frame as it is currently held in the position it needs to be, and dimensions are critical for its operation. Is this something you would be able to do?"*

Our engineer attended site, repairing the 7-inch crack in the casting by way of our stitching procedure for cast iron, giving 75% of original material strength, grinding up all stitching to correct profile and matching existing shape. After the stitching and inspection process, the repaired area was given a coat of primer, ready for the rebuild.
