# Slinden Services Ltd

Cast Iron Welding & Metal Stitching Repairs

## Kings Cross Columns

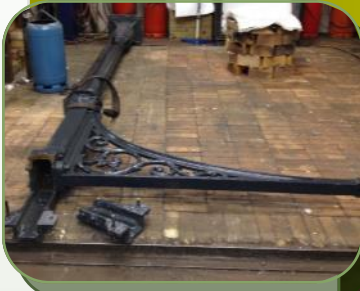
This canopy was an unhappy example of Victorian engineering with a large cantilever on one side which has had to be held up in recent years by props. At some point, two of the cast iron columns had been replaced with steel

girders, which did not replicate the appearance of the original structure. An award was granted to cover the cost of replacing these columns, and we were approached to manufacture the new cast iron columns and spandrels required.

our Engineers began the renovations. In association with our trusted foundry, patterns were made for the casting of the new components. Once these were manufactured, we set about making the spandrels fit, bolting to the columns, followed by shot blasting to SA 2.5 and applying two coats of primer
