Slinden Services Ltd

Loco Steam Exhaust

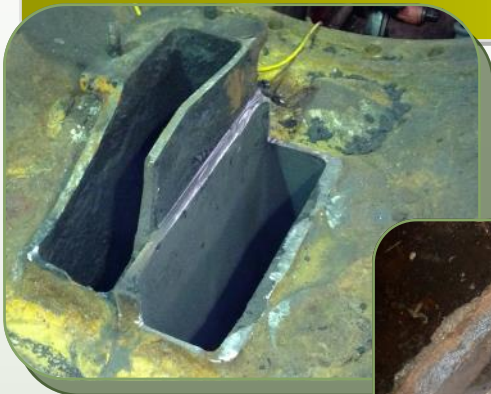
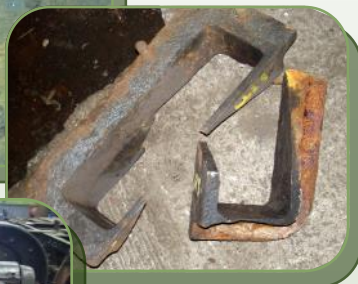
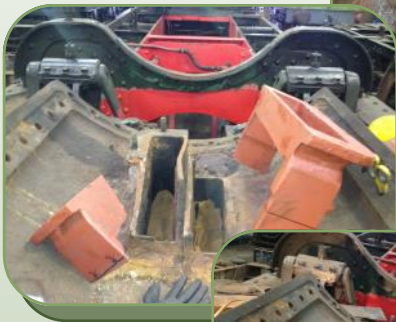
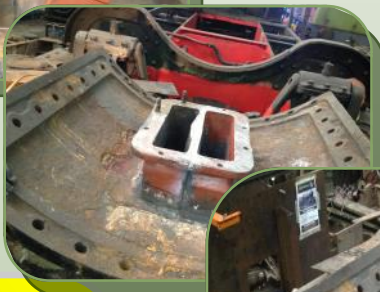
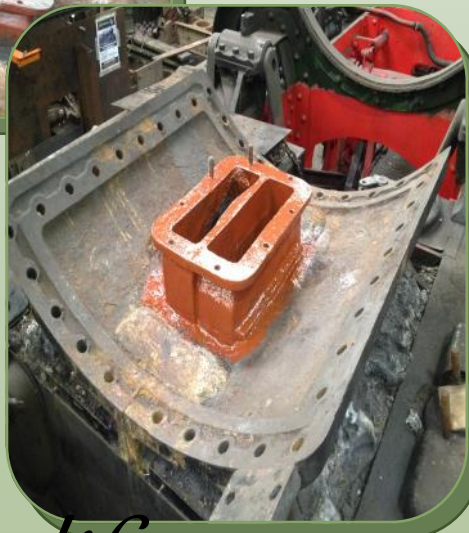
A Welsh railway company sent an enquiry regarding a damaged/eroded Loco Steam Exhaust. After initial consultation, we were able to offer our expertise in *both welding and metal stitching*.

This entailed our Engineers to go to site and collect the castings for initial Fusion Welding repairs at our workshops. After these repairs were completed, we were back on site to complete the repairs, by way of cutting and grinding to the repaired castings to ensure a perfect fit.

At this point we applied our Metal Stitching technique to secure the exhausts flanges back to the steam cylinders.

This was a good solid repair and will last for many more years to come.
