Slinden Services Ltd

MAK 601

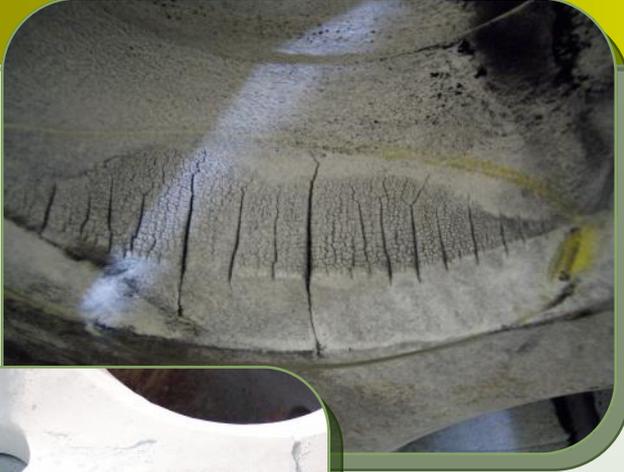
A MAK 601 Cylinder Head was received at our works - very badly burnt and cracked in the valve cage pocket.

This area was ground back to sound material and followed by our approved Fusion Welding Procedure.

The repaired area was then NDT inspected to ensure a sound repair had been undertaken then machined back to correct tolerances, spare parts were fitted, followed by thorough cleaning and painting ready for dispatch

The head was witnessed under pressure test by Lloyds for certification purposes prior to dispatch.
