# Slinden Services Ltd

Cast Iron Welding & Metal Stitching Repairs

## Maserati Block

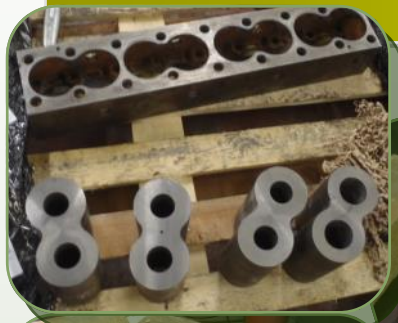
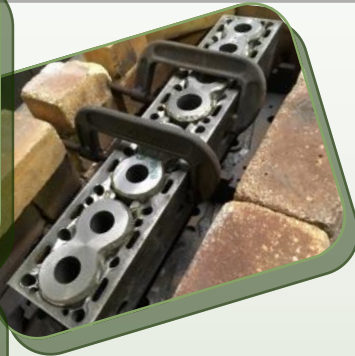
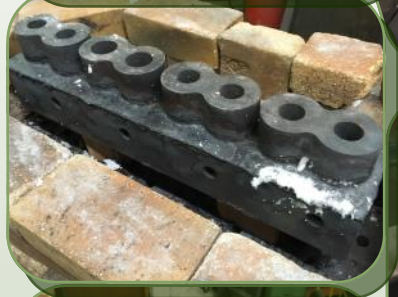
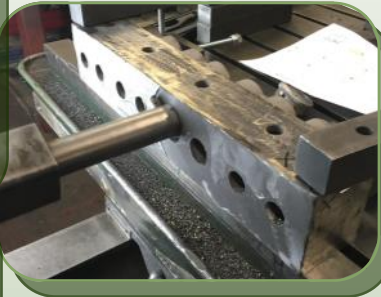
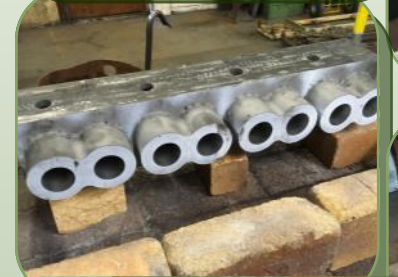
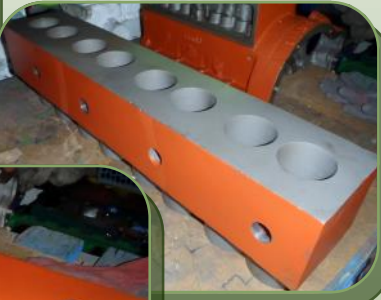
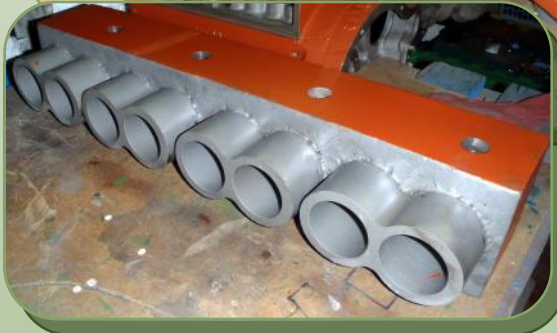
We were contacted by a customer with an 8-cylinder block from a classic Maserati car who explained, *"We are hoping to replace all the liners and thought that as pairs they could be machined and then welded in place by you - you came highly recommended by Julian of Historics in Belgium"*.

The block was delivered to our Derbyshire workshop where repairs were carried out by way of our Lloyd's approved fusion welding procedure for cast iron, installing 4 liner blocks and completely welding both crank face and head face before crack testing, post weld machining, and then pressure testing to ensure sound repairs had been undertaken. Afterwards, the block was cleaned and given a coating of red oxide primer, before its final inspection and return to the customer

for full machining and refit.
