Slinden Services Ltd

Cast Iron Welding & Metal Stitching Repairs

Ornamental Window Railing

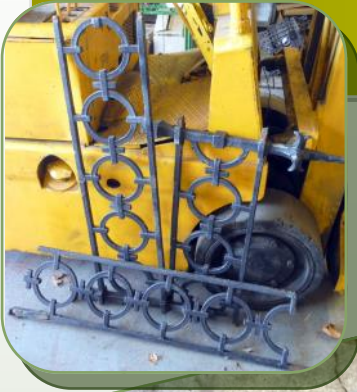
A customer requested our services to extend an architectural feature of a cast iron window railing to the ground floor front sill of his property on Fitzjohn's Avenue, NW3—which in its heyday would have had some extensive ironwork. He had acquired a railing of three metres long, but needed it to be closer to four!

It was brought in to our workshop, where repairs and refurbishments began with the casting of a new piece of railing, which was welded in seamlessly, along with two drop legs which were manufactured for fixing purposes, using our Lloyds approved fusion welding procedures. To make both ends of the railing symmetrical, the half-circle at the one end was removed, leaving each end finishing on a full circle. It was then blasted and crack tested, before painting, and shipping back to our customer for installation, and as the last pictures show, back to its former glory!
