Slinden Services Ltd

Yacht Keel Repairs

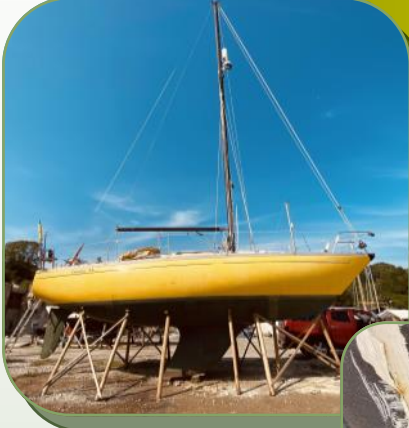
When we were contacted with a query regarding on site stitching repairs to a cracked cast iron yacht keel, our engineer travelled down to the Cornish boatyard prepared for the “worse-case scenario” until he was able to drill a couple of test sections to

determine the thickness of the material! He was able to repair the 10-inch crack by way of our stitching procedures for cast materials, giving a repair of 80% the original material strength. The repair was then ground up to the correct profile to match existing shape, and fully crack tested.
